Re: Results of Air Quality Monitoring - FY97 Second Quarter (FY97-2Q), (Event No. 17) Lees' Lane Superfund Site, Jefferson County, Kentucky Administrative Order on Consent, U. S. EPA Docket No. 91-32-C

Re: Report of Field Observation - FY 97 - Third Quarter (FY97-3Q), Lees Lane Superfund Site, Jefferson County, Kentucky, Administrative Order on Consent, USEPA Docket No. 91-32-C

Observation Report No.: FY97-3Q Date of Observation: 4/9/97

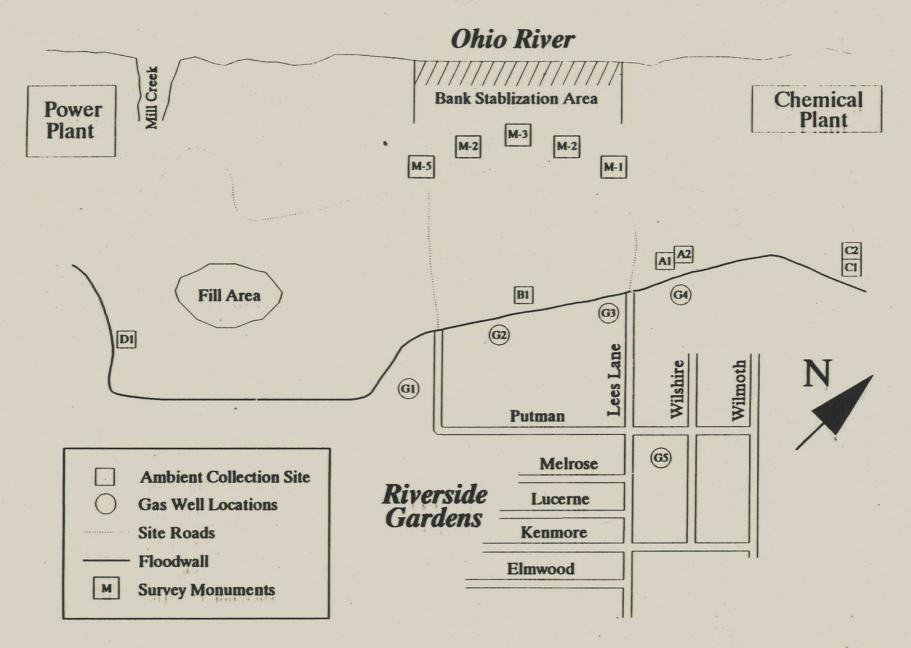
Figure 1. Lees Lane Landfill Sampling Locations

A map of the site, labeled with the sample collection locations for your reference, is shown in Figure 1. Table 1 is a tabular summary for the ambient sample with the primary analytes required for submission to EPA.
